# Manhole Inspection Summary

Manhole # S33QQ\_028MH

Insp Date: **4/23/07 1:19 PM**

**Location** Address: **115 25TH ST**

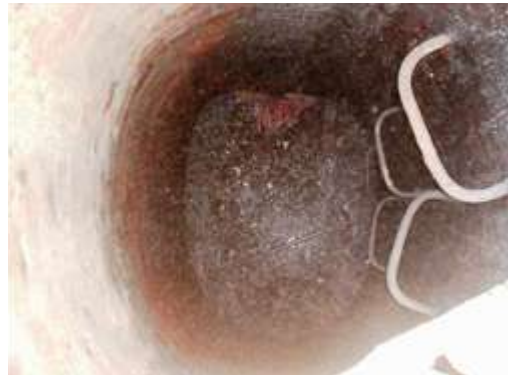
Top View

Channel debris.

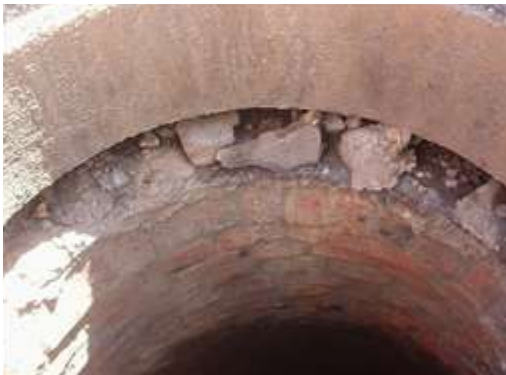
Defect

Frame leaks. Adjustment deterioration, loose brick and infiltration. Corbel infiltration.

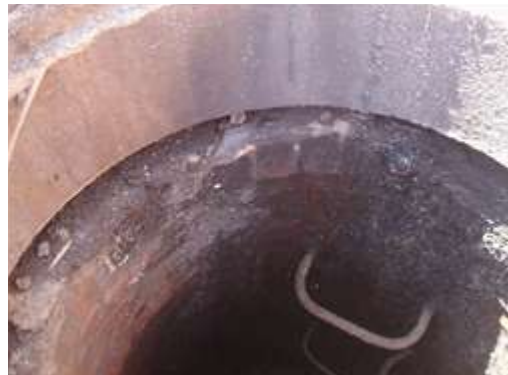
Defect

Frame leaks. Adjustment deterioration and infiltration. Corbel infiltration.

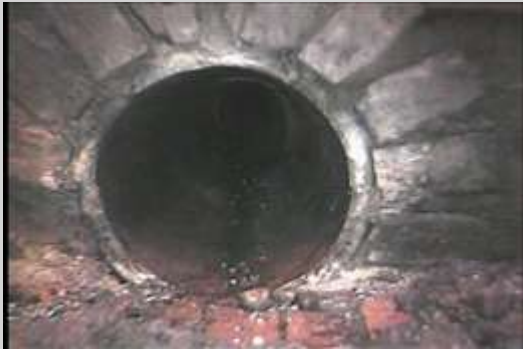
8 in. Circular Gravity Sewer  
Pipe Out @ 12 O'Clock

Infiltration: **Evidence** Pipe Seal Cond: **Unknown**
